Manhole Inspection Summary

Manhole # S25M__006MH

Location Address: **1272 Sargeant St**

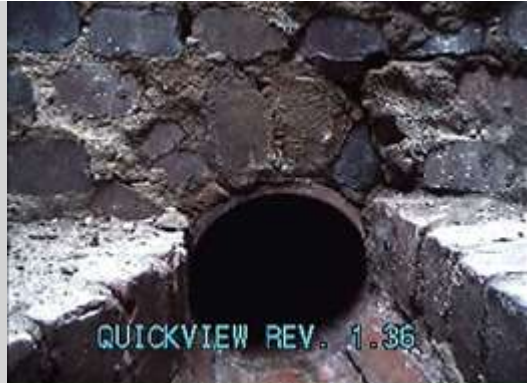
12 O'Clock Outflow

8 in. Circular Gravity Sewer
Pipe Out @ 12 O'Clock

Pipe Height: **8.4** (in.) Rod and Bar (Angled)
Pipe Material: **Clay** ☐ Pipe Lined
Invert Depth: **6.40** (ft.) Flow Characteristics: **Slow**
Deposits: ☒ None ☐ Mud ☐ Sludge ☐ Debris ☐ Grease
Silt Depth: **0** (in.) Deposits Extent:
Infiltration: **None** Pipe Seal Cond: **Sound**

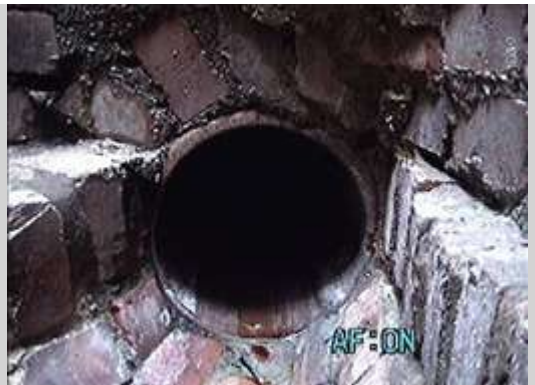
5 O'Clock Inflow

8 in. Circular Gravity Sewer
Pipe In @ 5 O'Clock

Pipe Height: **9.6** (in.) Rod and Bar (Angled)
Pipe Material: **Clay** ☐ Pipe Lined
Invert Depth: **6.32** (ft.) Flow Characteristics: **None**
Deposits: ☒ None ☐ Mud ☐ Sludge ☐ Debris ☐ Grease
Silt Depth: **0** (in.) Deposits Extent:
Infiltration: **None** Pipe Seal Cond: **Sound**

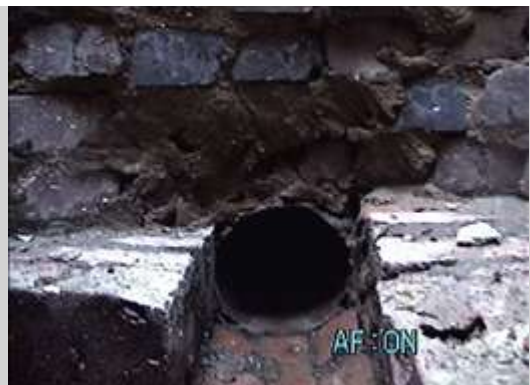
7 O'Clock Inflow

8 in. Circular Gravity Sewer
Pipe In @ 7 O'Clock

Pipe Height: **7.2** (in.) Rod and Bar (Angled)

Pipe Material: **Clay** ☐ Pipe Lined

Infiltration: **None**
